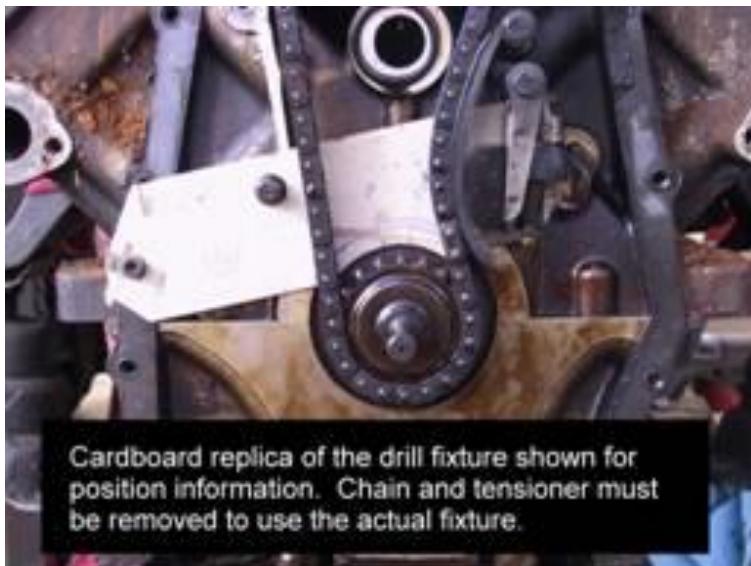
The original design of the engine did not provide a direct oil spray onto the primary chain. This may have contributed to the early wear of chains. While modern chains are significantly more durable than those originally fitted, it is possible to add the spray that Citroen fitted to all later engines and required to be done on reconditioning. In order to locate the spray correctly, the following jig is required.

Use of a cardboard replica jig to show general location

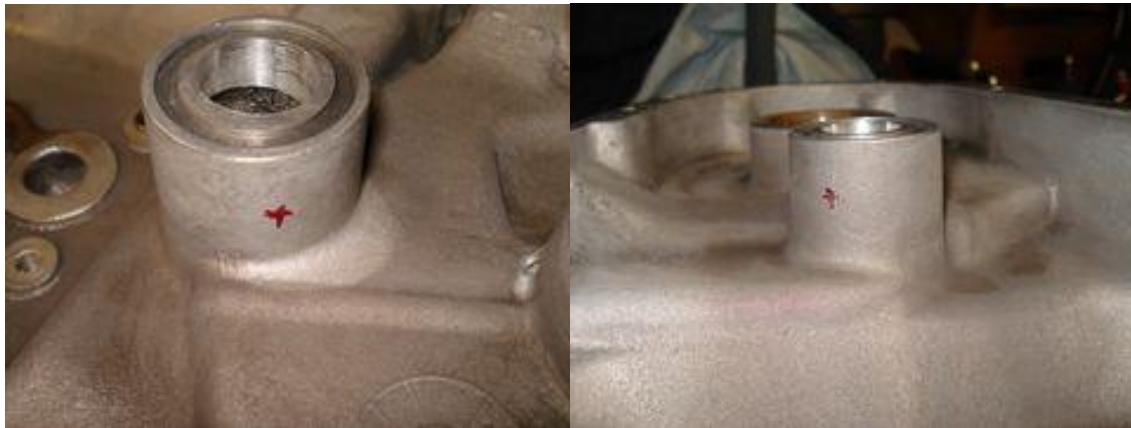
OOTFAB Dual Primary chain oiling holes

Holes are located at 2 o'clock and 7 o'clock facing the interior of the primary cover (10 o'clock and 5 o'clock facing the engine block). Holes are located 15mm back from the main oil passage mating face.

Consider the simpler alternative of modifying the main oil passage in the primary cover to create two oil spray holes for the primary chain. Requires no modification of engine block. Requires only an angle drill and basic measuring skills.

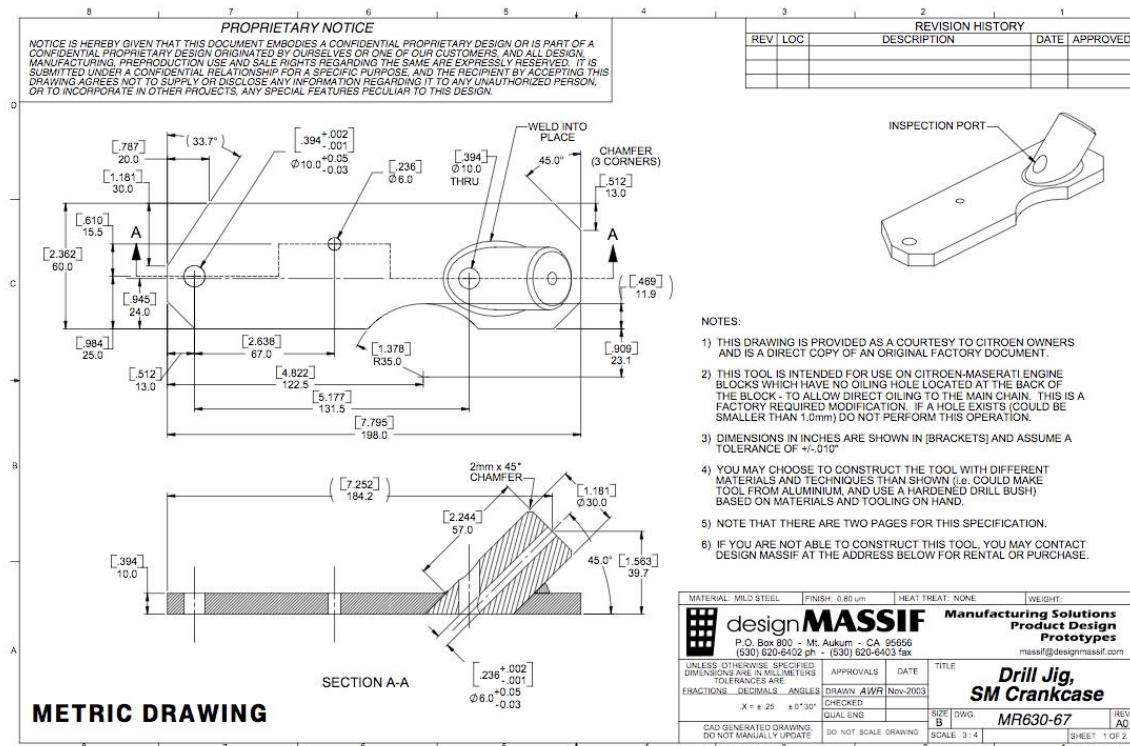
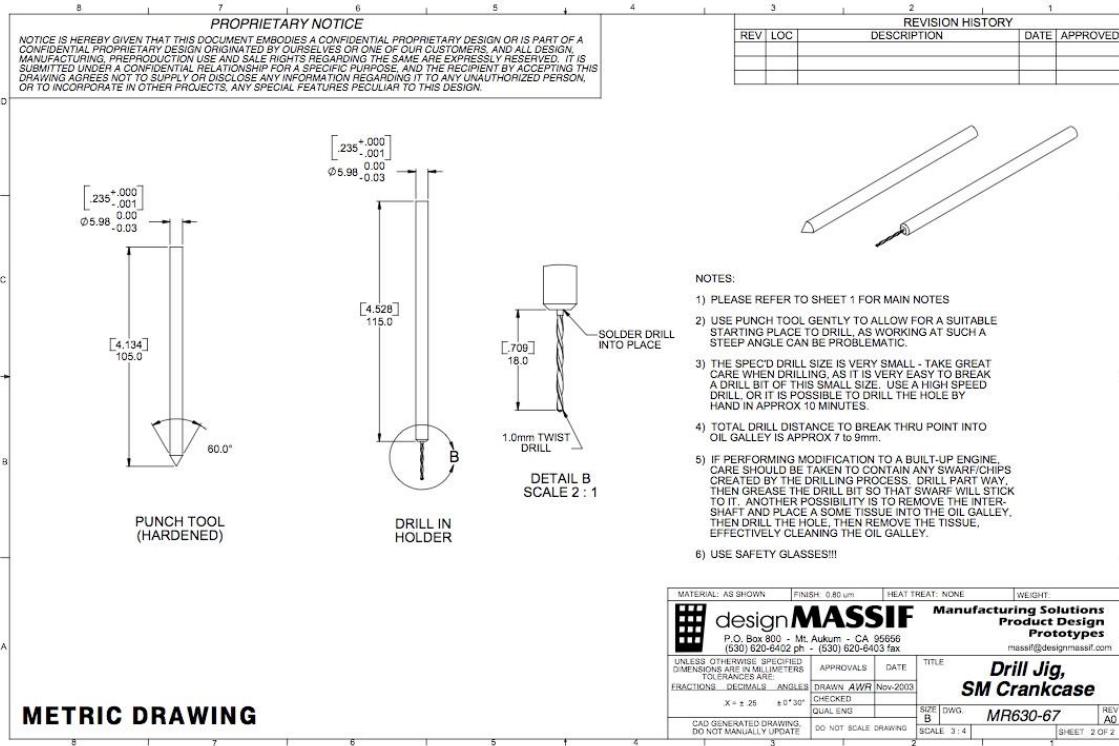
The original factory-fitted hole was 0.5mm. Citroen specifies 1.0mm in this jig, possibly because of the care needed with the smaller drill. This 'modified from the original' jig allows the hole to be drilled without completely stripping or removing the engine, and can use a 0.5mm drill.
